Nama Customer : Bu Alex  
 No. Telp : 08180000000  
 Jenis & Tahun Kendaraan : Lexus RX300 2021  
 Plat Nopol : B 0000 XXX  
 Jarak Tempuk KM Mobil : 15.362

# AUTORF

## CAR INSPECTOR

#### FOTO-FOTO TEMUAN

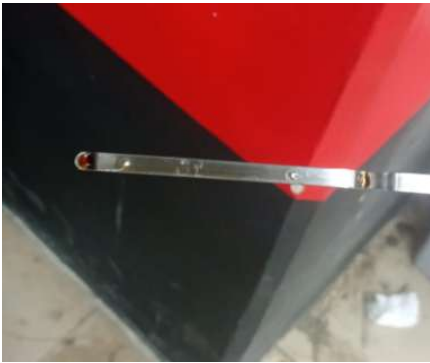
| No | ITEM | KONDISI | CATATAN |
|---|---|---|---|
| 74 | Oli Mesin Buka Dipstik (Warna, Level) | Δ | Oli sedikit menghitam. |

1. Oli mesin sedikit berwarna hitam

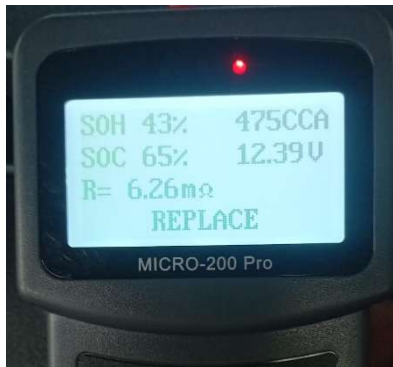
| No | ITEM | KONDISI | CATATAN |
|---|---|---|---|
| 82 | AKI (Cek tegangan > 12.5V) | X | AKI Lemah, tegangan 12.39V (SOH 43%, SOC 65%) |

2. AKI lemah

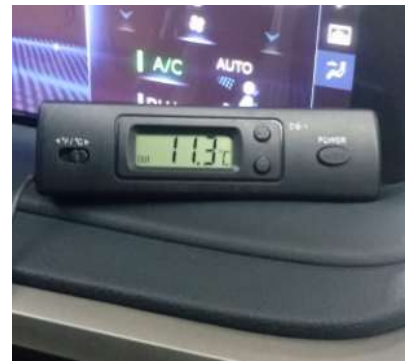
| No | ITEM | KONDISI | CATATAN |
|---|---|---|---|
| 88 | Suhu AC (STD <10°C) | Δ | Suhu 11.3°C, kondisi dingin namun di atas standard (standard dibawah 10°C). |

3. Kondisi dingin namun di atas standard (STD dibawah 10°C).
